SAUK RIVER CED RETROFIT

JANUARY 31, 2005

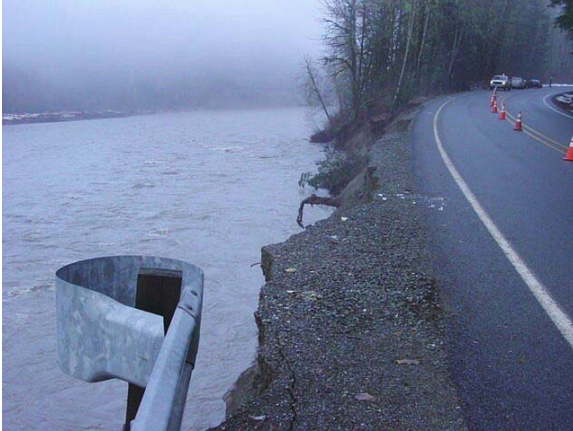
Streambank damage at SR 530/Sauk River CED site; October 2003

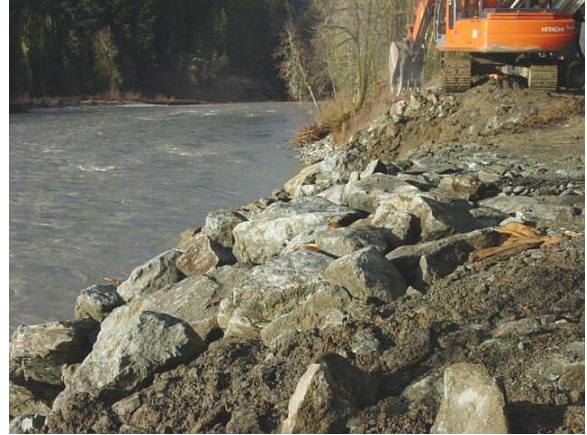
Emergency repair work at site; 11/2003.

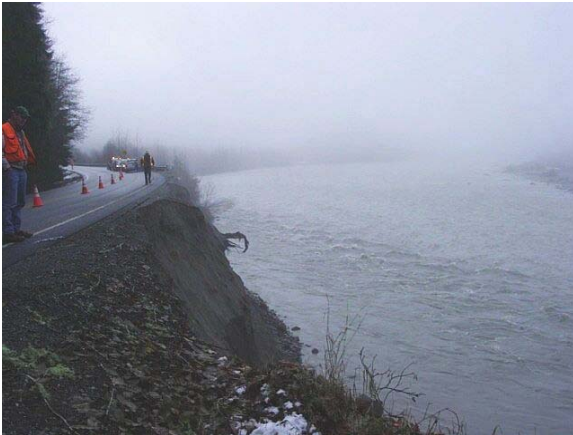
Streambank damage at SR 530/Sauk River CED site; November 19, 2003.
